COMPOSITE REPAIR FOR SUBSEA PIPE REINFORCEMENT

According to ISO 24.817 & ASME PCC-2

DEFECTS TYPE	2 dents in subsea environment
PIPE DETAILS	48" oil line – max. op. temp. 35°C – op. pressure 18.2 bars
LOCATION	QATAR – Halul Island
3X SOLUTION	REINFORCEKit® 4D SUBSEA (R4D-S)

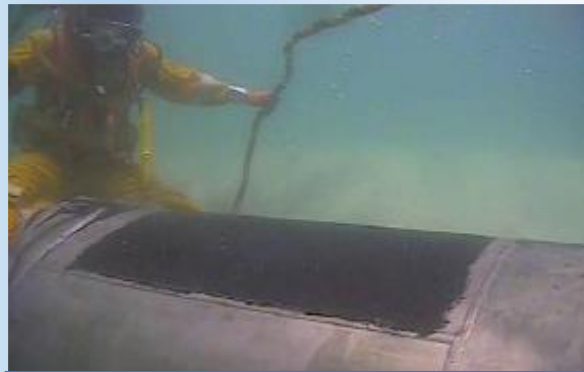
Figure 1: P3X30 primer application on defected area (step 2)

- ② **P3X30 primer** application right on the defect to ensure a good bonding of the composite plate (step 3).
- ③ **F3XSS filler** application on rigid composite plate. The plate was then given to the diver and positioned over the dent and fastened tightly with ratchet belts (previously installed – see step 1).

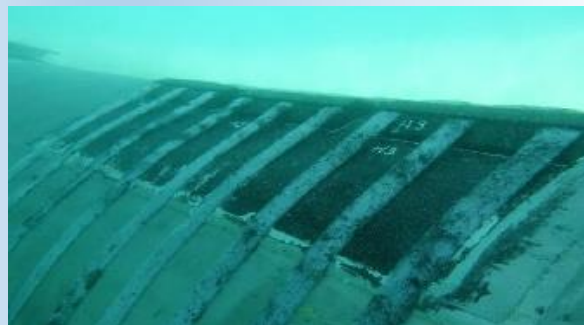
Figure 2: Composite plate application using F3XSS filler and ratchet belts (step 3)

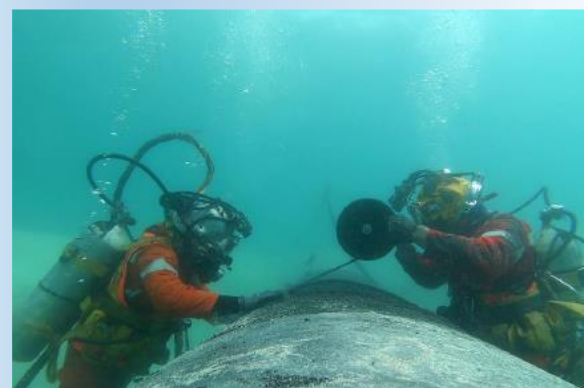
Figure 3: Composite wrapping on progress (step 5)

- ⑤ Kevlar® tape impregnated with **R3X1050S resin** and wrapped around the pipe. The tape impregnation was performed using BOBIPREG (3X specific machine allowing a quick and regular impregnation resin/fiber). Thirty-two layers were necessary to repair the defect (i.e. 16 passes of 50% overlap) for a total of 3m repair length.

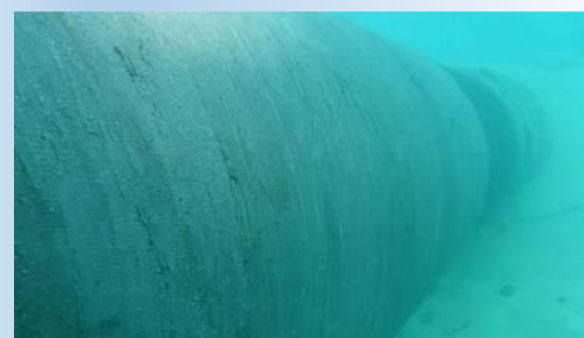
Figure 4: Repair overview

- ⑥ Finalization of the repair with reference plate positioning for traceability purpose and validation of the repair using hardness measurements.
