COMPOSITE REPAIR FOR PIPE REINFORCEMENT

According to ISO 24.817 & ASME PCC-2

DEFECT TYPE	External corrosion at weld connection
PIPE DETAILS	12" gas line – Operating temperature: ambient (20°C) - Pressure 64 bars
LOCATION	AUSTRIA – Aerial pipeline
3X SOLUTION	REINFORCEKIT® 4D – EC

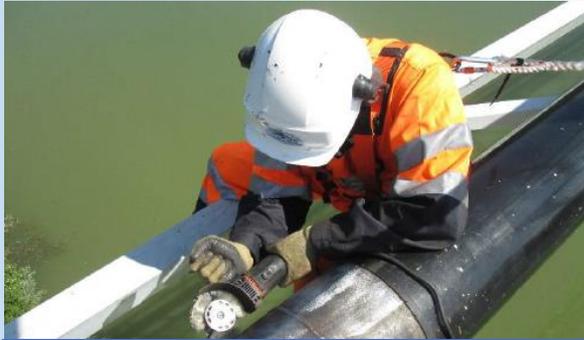
Fig. 1: Surface Preparation using Bristle Blaster®

Before starting the reinforcement, the coating was removed each side of the weld to have enough length for composite application. Surface preparation was then completed using Bristle Blaster® machine to get a good surface state and surface profile. Finally, the whole prepared surface was cleaned with acetone and roughness test and hygrometric measures were performed to ensure that all the conditions were satisfying before composite application.

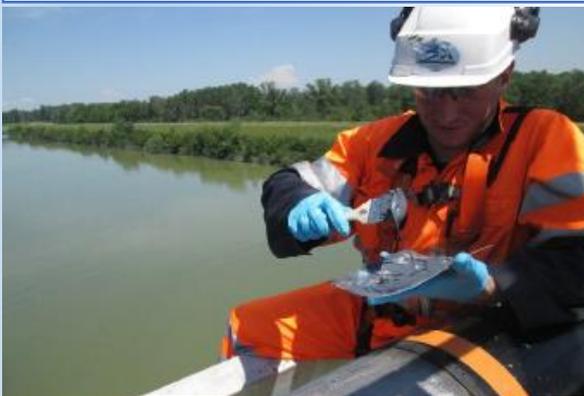
Fig. 2: F3X8 filler application

- 1/ **F3X8 filler** application on weld and defect to reshape the pipe.
- 2/ **R3X1060 resin** application on the whole surface to protect it from corrosion.
- 3/ Wrapping process using **Kevlar® tape impregnated with R3X1060 resin** → 4 layers completed for a total repair length of 400mm.
- 4/ Finalization of the repair. **R3X1060 resin** application over the repair to ensure good wetting of the fibers and good visual aspect and identification plate application for traceability purpose.

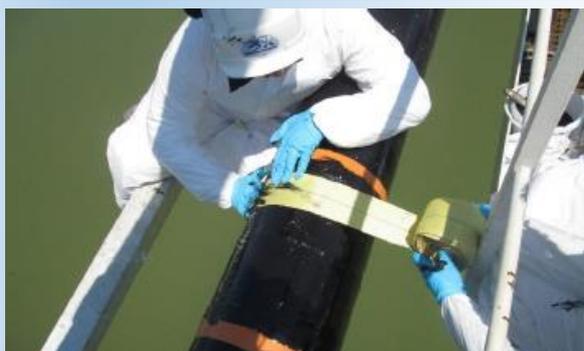
Fig. 3: Composite wrapping on progress

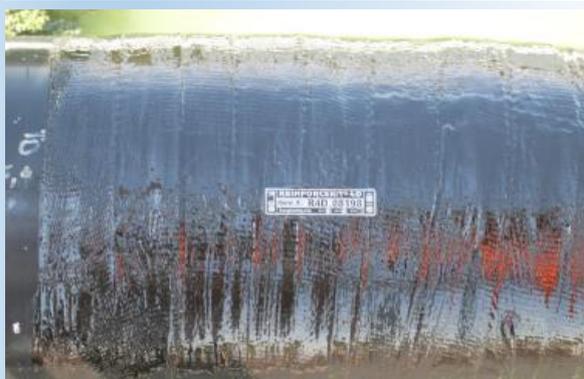
Fig. 4: Repair overview with ID plate
