## COMPOSITE REPAIR FOR PIPE REINFORCEMENT

According to ISO 24.817 & ASME PCC-2

DEFECT TYPE	<b>Pipe subjected to compressive stress</b>
PIPE DETAILS	<b>30" pipe – Operating temperature 45°C - Pressure 600 psi</b>
LOCATION	<b>COLOMBIA</b>
3X SOLUTION	<b>REINFORCEKIT® 4D – EC</b>

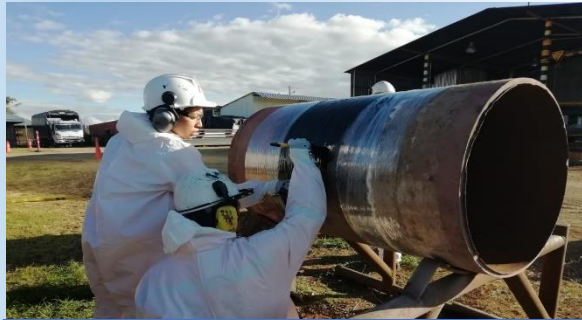
Figure 1: Pipe to be reinforced

1/ Before the repair, qualified staff of CPSEVICES inspected and delimited the area to be reinforced.

2/ Surface preparation was carried out by an external contractor using manual-mechanical tools to obtain a good surface roughness (between 60 and 100 µm) and thus guarantee the bonding between the steel pipe and the composite.

3/ The surface was cleaned with ethanol and the hygrometric conditions were checked before wrapping process.

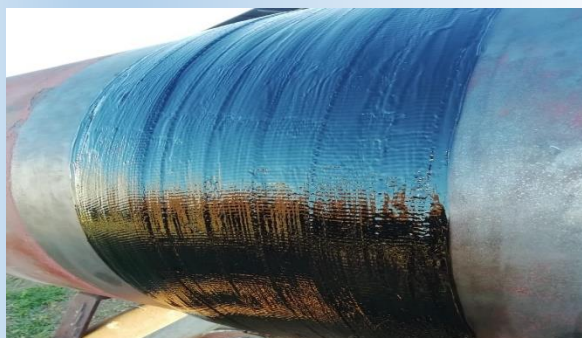
Figure 2: Wrapping completed

4/ Wrapping composite reinforcement covering the delimited area was completed using **Kevlar® tape impregnated with R3X1060 resin** (4 layers with a specific repair length according to the characteristics of the loads to which the 30" pipe would be subjected).

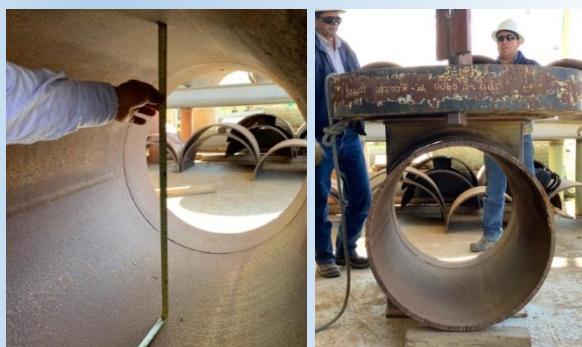
Figures 3-4: Measurement of inner diameter and initial loading

5/ Once wrapping completed, the inner diameter was measured in order to detect any final deformation.

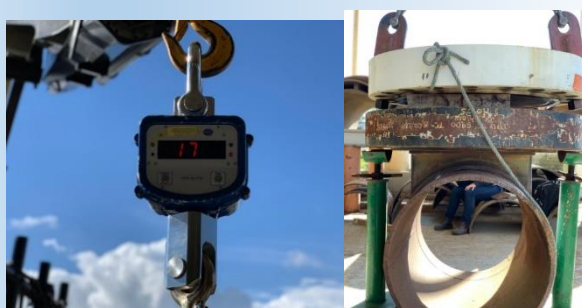
The pipe reinforced with **REINFORCEKIT® 4D-EC** was subjected to 3.5 tons of external loads without presenting any type of damage or deformation. The lifetime of this composite reinforcement is 20 years.

Figures 5-6: 3,5 tons of loads applied on reinforced pipe

6/ Finally, two external loads (1.75 tons each one) were applied to check the resistance of the pipe.
