COMPOSITE REPAIR FOR PIPE REINFORCEMENT

| DEFECT TYPE | External corrosion – 4 defects |
| PIPE DETAILS | 10" and 12" – Oil lines – design temperature 70°C - design pressure 40 and 200 bar |
| LOCATION | THE NETHERLANDS – Platform (Offshore on air) |

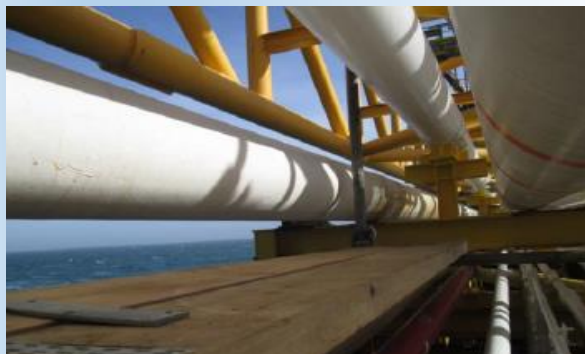
Fig. 1: Working conditions – View of scaffoldings

Because of the complex pipes situation, the client provided scaffoldings to perform the repair.

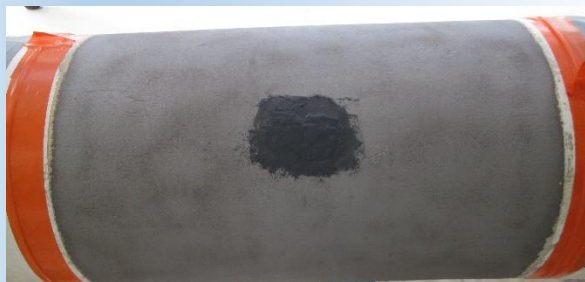
Fig. 2: View of the delimited repair area to be wrapped & Example of filler F3X8 application on 12" pipe defect

Before starting the composite reinforcement, 3X technicians first recognized and delimited the repair areas with adhesive tape. Surface preparation was completed with grit blasting to get a good surface roughness (between 60 and 100µm) and ensure the bonding between the steel pipes and the composite. The surface was then cleaned using acetone and hygrometric conditions were checked before wrapping procedure.

- ① **F3X8 filler** application on each defect to give back the initial shape to the pipes.
- ② Wrapping process covering the delimited areas was completed using **Kevlar® tape impregnated with R3XHT+ resin** (4 layers for each defect but with a specific repair length in accordance to defect characteristics → 260mm repair length for both 10" line defects, 457mm and 1060mm for the defects on 12" line).
- ③ **Reference plate** for traceability purpose was positioned on each repair.

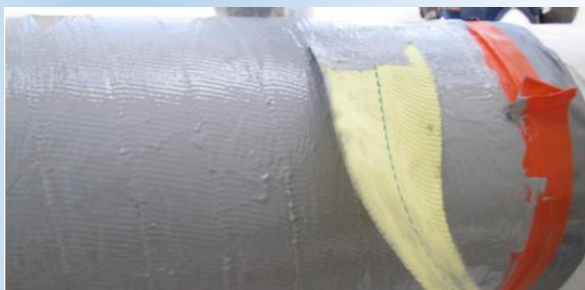
Fig. 3: Wrapping in progress

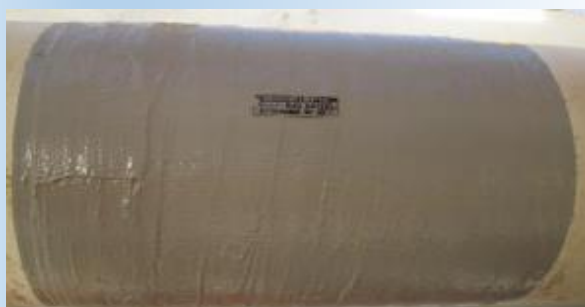
Fig. 4: Wrapping completed & Identity plate installed

The lines suffering from external corrosion were successfully repaired using our **REINFORCEKIT® 4D HT+**. Hardness measurements were performed and concluded the success of the repair. The design life for this composite reinforcement is 10 years.
