COMPOSITE REPAIR FOR PIPE REINFORCEMENT

According to ISO 24.817 & ASME PCC-2

DEFECT TYPES	Cracks
PIPE DETAILS	MDEA Regenerator column - 264" – MDEA / Acid Gas – max op. temperature 90°C - design pressure 1 bar
LOCATION	LIBYA
3X SOLUTION	REINFORCEKIT® 4D – High Temperature

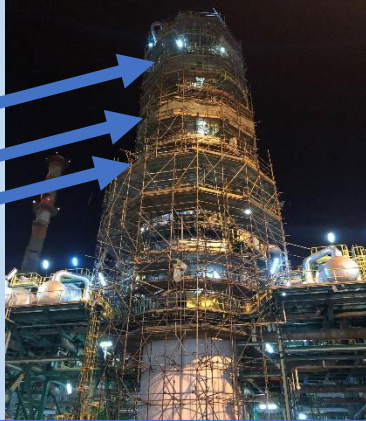
Scaffolding levels with welds

Fig. 1: Column overview with welds location

The objective of the repair, carried out end of December 2019 by 3X ENGINEERING (3X) and its local distributor AL MAIDA, was to **reinforce 3 circumferential welds suffering from cracks, situated on a huge column.**

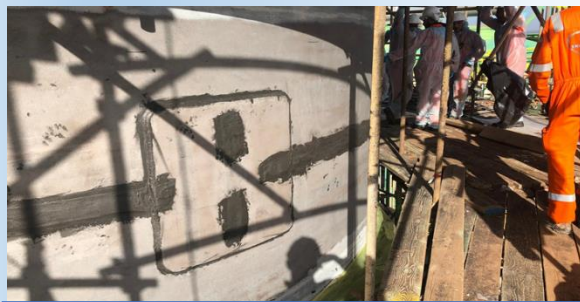
Fig. 2: F3XS1 application on weld

- 1 **F3XS1** filler was applied on the weld to smooth the shape and improve the Kevlar® tape fitting on the column.
- 2 **R3XHT+** resin was applied on the surface to ensure the perfect impregnation of the Kevlar® tape.
- 3 Composite wrapping was completed using **Kevlar® tape impregnated with R3XHT+ resin** → 4 layers and 1270mm repair length for each defect. During the process, tape impregnation was checked on both sides to ensure the expected performance.
- 4 Finalization of the repair. A layer of **R3XHT+** was applied all over the repair to ensure good wetting and improve the visual aspect. **Reference plate** was installed on each repair for traceability purpose.

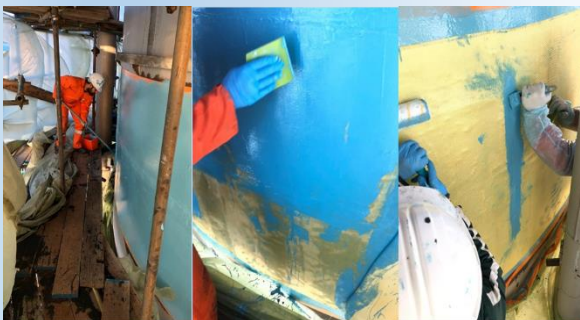
Fig. 3-4-5 : Wrapping in progress

According to ISO 24.817 and 3X repair calculations, 4 composite layers of **REINFORCEKIT® 4D HT+** (specifically dedicated to high temperature) were determined to reinforce the defects.

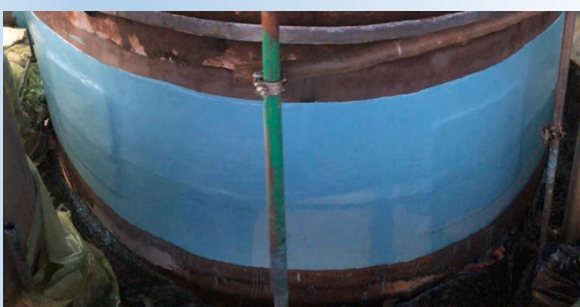
Fig. 6: Wrapping completed (4 layers)

Hardness measurements were performed 3 days after job completion and concluded the good achievement of the repairs. This project was challenging because of the large column diameter and the time frame for completing the job. The column was successfully reinforced on the weakest areas and is now protected from leaking issues.
