COMPOSITE REPAIR FOR PIPE REINFORCEMENT

According to ISO 24.817 & ASME PCC-2

DEFECT TYPES	External corrosion – 6 defects
PIPE DETAILS	2" & 6" straight line, elbow, pipe on support and flange – hydrocarbon gas – operating temperature 80°C - operating pressure <12 bar
LOCATION	MALAYSIA – Puteri Platform
3X SOLUTION	REINFORCEKIT® 4D – High Temperature

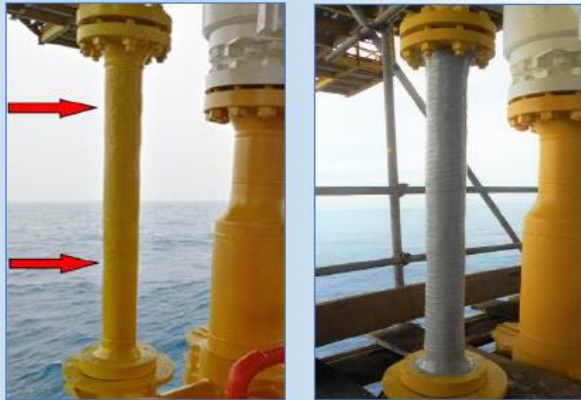
Fig. 1-2: Straight line reinforcement (before/after)

- ① **F3X8 filler** was applied on the pipe.
- ② Wrapping process covering the delimited areas was completed using **Kevlar® tape impregnated with R3XHT+ resin** (2 layers for each defect → from 188mm up to 1085mm repair length).
- ③ **Reference plate** was installed on each repair for traceability purpose.

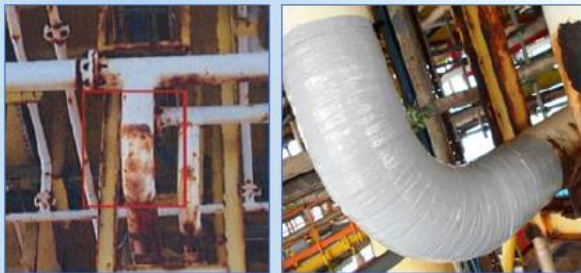
Fig. 3-4: Elbow reinforcement (before/after)

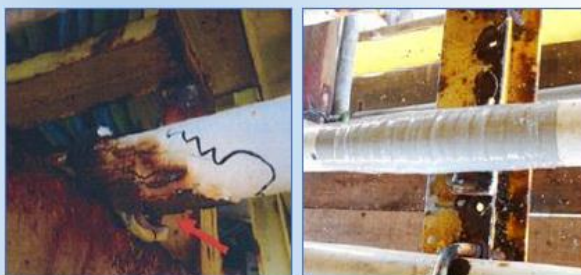
Fig. 5-6: Pipe on support reinforcement (before/after)

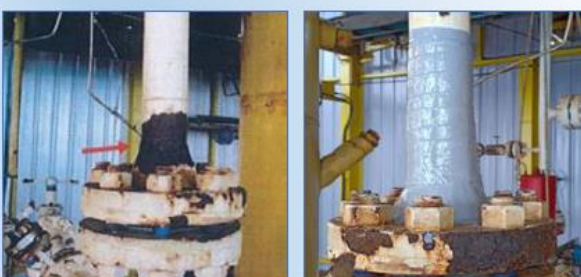
Fig. 7-8: Flange reinforcement (before/after)
