COMPOSITE REPAIR SPECIALIST

- **TYPE OF DEFECT :** Dent defect in subsea environment with **ZERO VISIBILITY**
- **PIPE DETAILS :** **36" OD – operating temp. 25°C – max. op. pressure 362 psi**
- **LOCATION :** **Qua Iboe Terminal – Offshore Nigeria (BOP)**
- **3X PRODUCT :** **REINFORCEKIT 4D SUBSEA (R4D-S)**

OVERVIEW

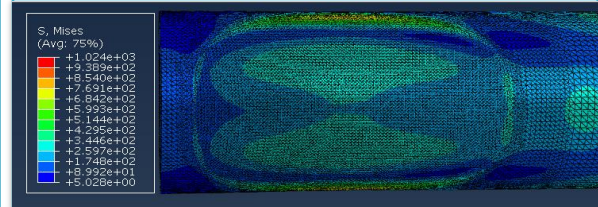
Design of the repair by Finite Element Analysis.

- After Finite Elements Analysis (FEA), 50 composite layers of **REINFORCEKIT 4D SUBSEA (R4D-S)** product have been determined to perform the reinforcement designed for 5 years.

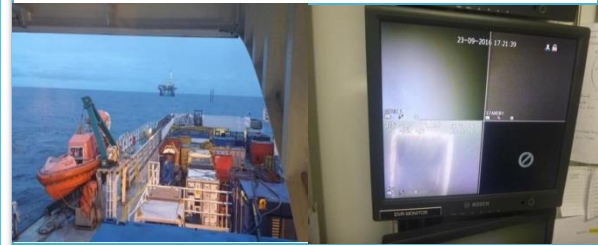
Deck view of the vessel and divers screen control.

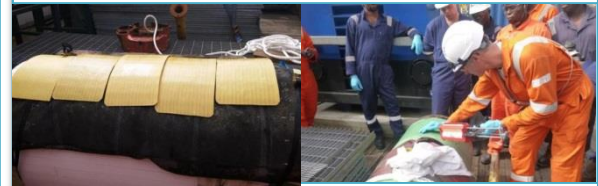
Composite plate manufacture on the foot print of the dented area & primer application (training picture).

1/ A foot print of the dent has been done in order to manufacture appropriate composite rigid plate.

2/ Primer (P3X32) application on the defect, using a dispensing gun, to provide a good adhesion of the composite materials.

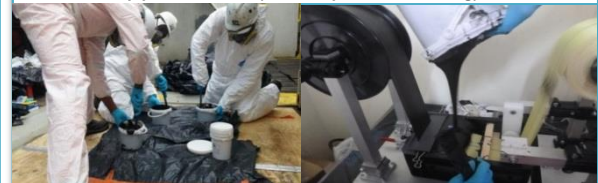
Mixing of the resin and tape impregnation using BOBIPREG (3X specific tool) to avoid lack of resin.

4/ Kevlar® tape pre-impregnated with R3X1050-S resin (using special 3X device called BOBIPREG) wrapped around the pipe. 82 Kevlar® rolls were necessary to cover the dent with the appropriate thickness composite needed.

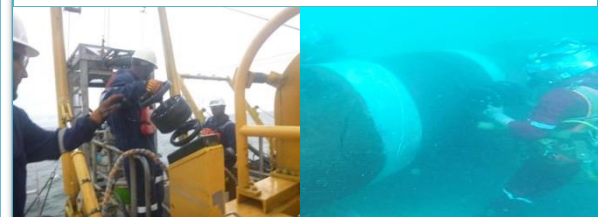
3X divers wrapping tool sent on a basket for divers & divers composite application (ILLUSTRATING PICTURE ONLY).
