# COMPOSITE REPAIR SPECIALIST

- **TYPE OF DEFECT :** Dent damage in subsea environment
- **PIPE DETAILS :** 18" OD – design temp. 60°C – design pressure 138 barg
- **LOCATION :** VIET-NAM, Ca Mau
- **3X PRODUCT :** REINFORCEKIT 4D SUBSEA (R4D-S)

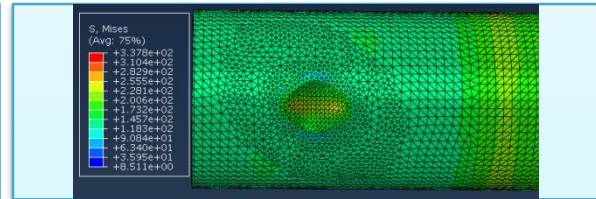
- Finite Elements Analysis (FEA) simulation has been performed by 3X to determine the number of layers necessary to perform the reinforcement → 60 composite layers of **REINFORCEKIT 4D SUBSEA (R4D-S)** product have to be implemented.

Design of the repair by FEA (stress distribution after repair)
