# COMPOSITE REPAIR SPECIALIST

- **TYPE OF DEFECT :** Dent damage in subsea environment
- **PIPE DETAILS :** 16" OD – design temp. 65°C – design pressure 92.5 barg
- **LOCATION :** VIET-NAM, Su Tu Vang
- **3X PRODUCT :** REINFORCEKIT 4D SUBSEA (R4D-S)

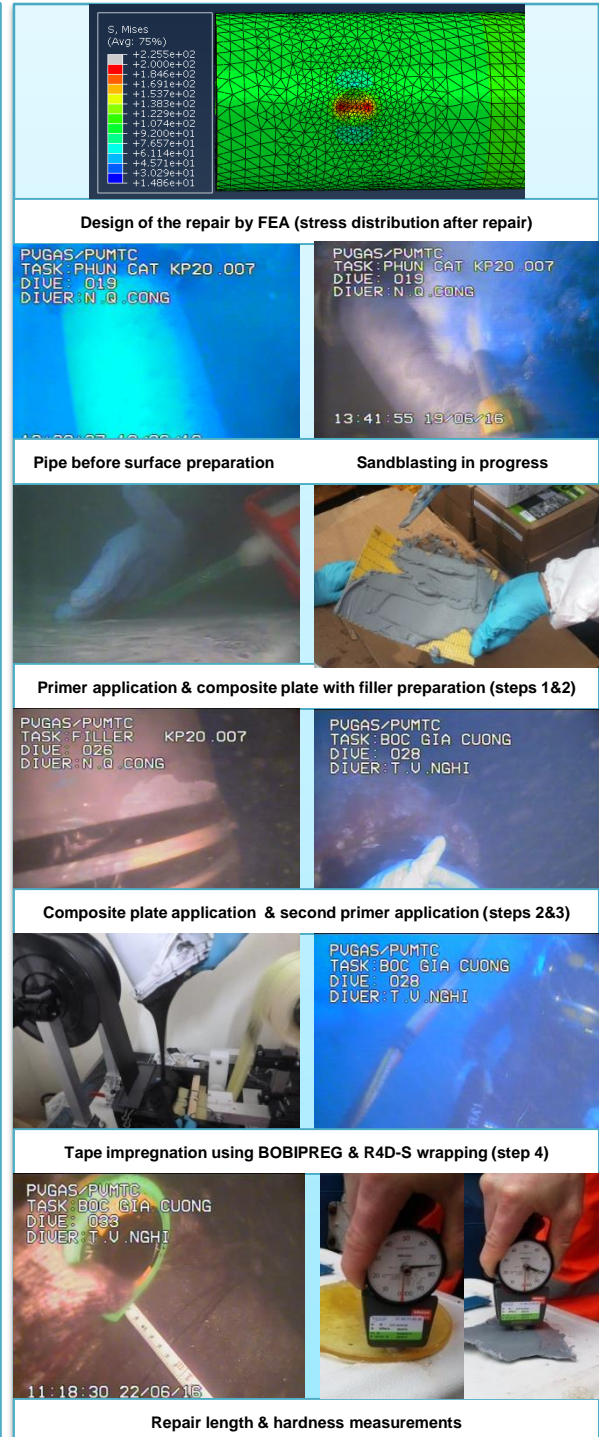
The objective of the repair performed in June 2016 by 3X ENGINEERING (3X) and its local distributor PETROENERTECH was to **reinforce a damaged subsea pipe section over 1 meter length, due to dent defect situated at 55-meter depth (3.3 % dented depth).**

- Finite Elements Analysis (FEA) simulation has been performed by 3X to determine the number of layers necessary to perform the reinforcement → 30 composite layers of **REINFORCEKIT 4D SUBSEA (R4D-S)** product have to be implemented.

- Several preliminary actions have been performed underwater (identification of the defected area, removal of concrete and existing concrete ...) prior to prepare the surface with sandblasting device. This step is absolutely necessary to get a good surface roughness (60-micron surface profile). To blast the whole surface to be repaired, 5 dives were conducted.

- 3X wrapping reinforcement has been performed following several stages :

**1/** Primer (P3X32) application on the whole defect to provide a good adhesion of the filler.

**2/** A rigid composite plate coated with F3XSS filler to rebuild the pipe shape has been positioned over the dent and strongly fixed with ratchet belts during few hours.

**3/** Second P3X32 application performed on the whole pipe surface to be repaired before wrapping.

**4/** Kevlar® tape pre-impregnated with R3X1050-S resin (using special 3X device called BOBIPREG) wrapped around the pipe. Thirty layers were necessary to cover the dent (i.e. 15 passes of 50% overlap).

-To make sure the repair was conform to requirements, various measurements have been taken (total length of the repair, repair circumference and hardness measurements).

The 16" sea line was efficiently completed within 2 days. The total length of the repair was 1.05m. This project was a big challenge because of the 55-meter depth which is a very restrictive environment and needs diving limited times. Thanks to our experience in subsea repairs added to the great collaboration between PETROENERTECH, client representatives and PVMTC divers, this subsea repair was one more success.
