DEFECT TYPE	Subsea caisson reinforcement
PIPE DETAILS	Sea water caissons (from 920 to 960mm OD) – Calculated pressure 6 bar - Installation temperature 14°C
LOCATION	NORWAY (North Sea)
3X SOLUTION	REINFORCEKIT® 4D SUBSEA (R4D-S) – Low Temperature

The objective of the repair, performed early July 2018 by **3X ENGINEERING (3X)** and its local distributor **FUGLESANGS**, was to **reinforce 3 subsea caissons damaged by 10 defects** at Oseberg South platform, located in the North Sea. These caissons presented notches and holes (**holes to be sealed up to 300mm in diameter**) caused by corrosion. In 2012, after inspection and confirmation of corroded defects, temporary patches with metal strips were installed on the holes as emergency solution.

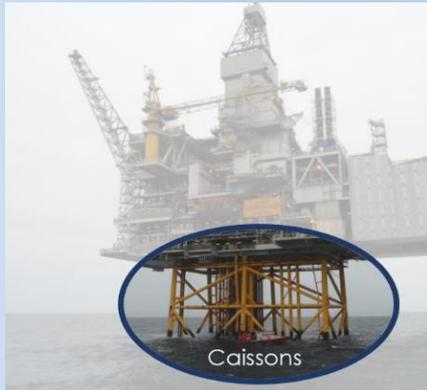
Fig. 1: View of the platform and caissons

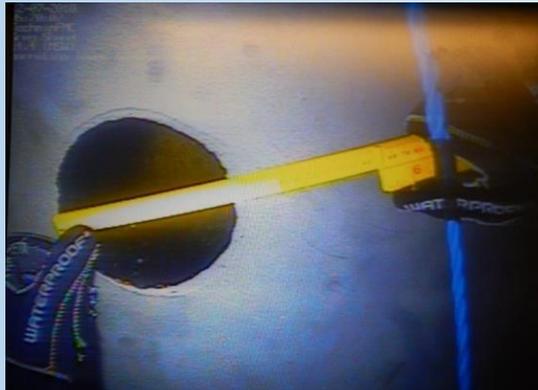
Fig. 2: Measurement of the defects

Before 3X intervention, divers inspected the 3 caissons to take new measurements of the defects.

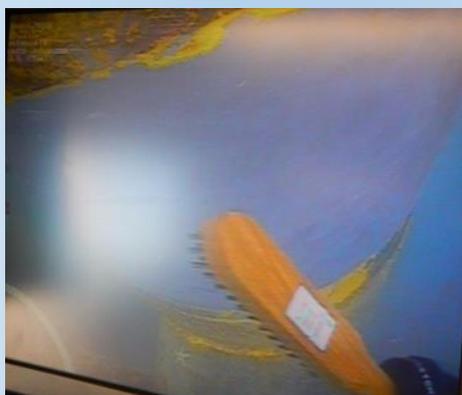
Fig. 4: Cleaning of the surface using metallic brush

- ① **Cleaning of the prepared surface.** Due to sea conditions (waves, currents), the dives were not performed continuously waiting for safe conditions. It was therefore necessary to clean and remove the flash corrosion and sea life residues that appeared from the last dives using a metallic brush.

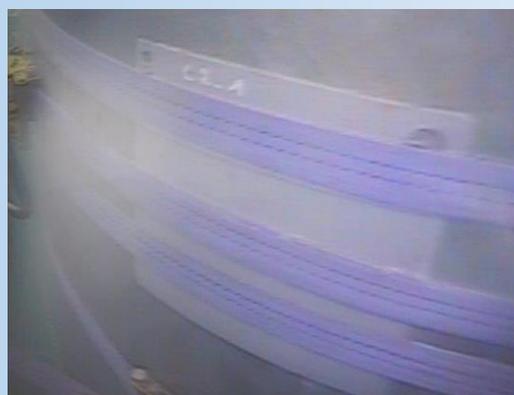
Fig. 5: Metallic plate application over the defect using ratchet straps

- ② **Metallic plates application over the holes.** Each hole was covered by a metallic plate (previously prepared on-site to fit with defect size) and sealed with **F3XUW9 high-performance filler curing underwater** using ratchet straps and magnets. After 2 hours of curing, the straps were removed.

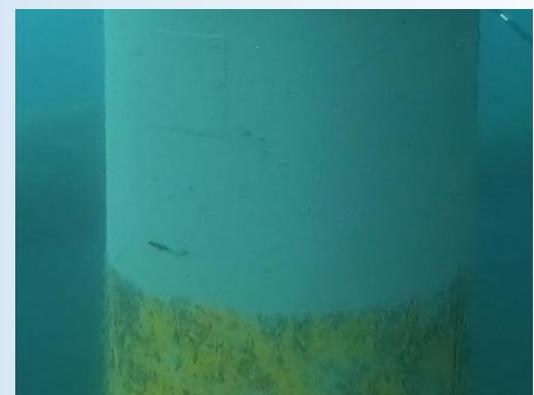
Fig. 6: Primer application over the whole surface to be repaired

- ③ **Primer application over the entire surface to be repaired.** The whole areas to be wrapped, including metallic plates, were covered using **P3X28 specific primer for subsea use**. It will protect the caisson from corrosion and will ensure the bonding between the steel and the composite.

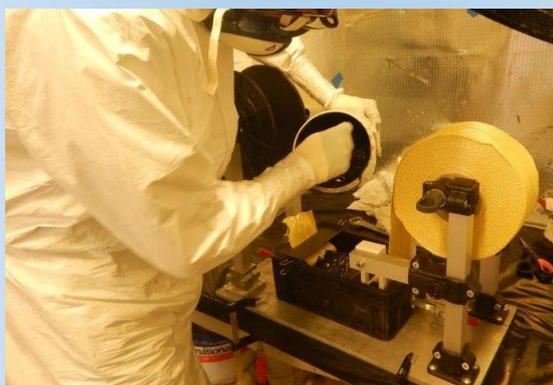
Fig. 7: Tape impregnation with resin using BOBIPREG®

- ④ **Composite wrapping.** The wrapping process, using **Kevlar® tape impregnated with R3X1050S resin (R4D-S)**, was performed either with the **Tape Wrapping Machine (TWM)** or manually by the divers depending on defect location. For straight repairs the TWM was used. For the repairs located on tee, the manual wrapping was preferable. In both ways, Kevlar® tape was wrapped helicoidally around the pipe with 50% covering. The impregnation of the **Kevlar® tape with R3X1050S resin** was made using **BOBiPREG®** machine (specific machine designed by 3X that allows a quick and regular impregnation of the tape with the resin before application). **The repair length of each defect varied between 780 to 2340mm for a total composite wrapping length of 6800mm.**

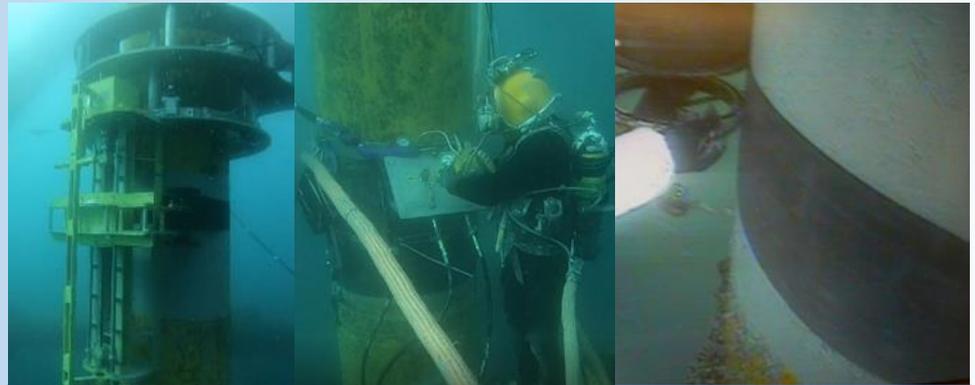
Fig. 8-9-10: Mechanical (Tape Wrapping Machine) and manual wrapping on progress
