DEFECT TYPE	Leaking defect
TANK DETAILS	Crude oil storage tank
LOCATION	Araguaney Station - CASANARE, COLOMBIA
3X SOLUTION	TANKIT®

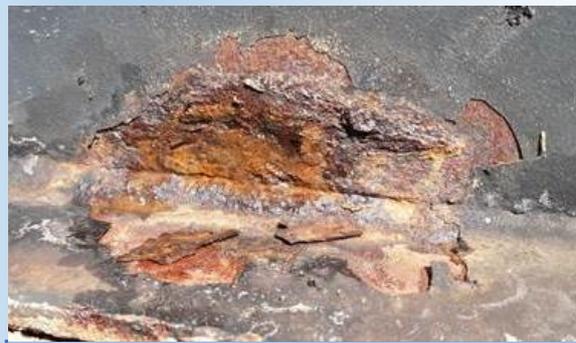
Fig. 1: View of the defect

The objective of the job performed in 2019 by 3X ENGINEERING (3X) distributor in Colombia – CPS - was to **reinforce a crude oil storage tank by sealing a leak situated on the first ring of the tank (due to external corrosion)**.

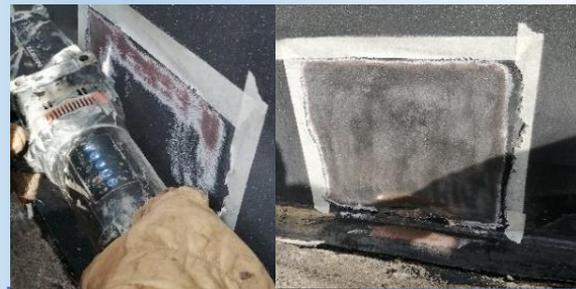
Fig. 2: Surface preparation in progress using Bristle Blaster®
Fig. 3: Surface preparation of the defected area completed

The work team carried out the surface preparation, using Bristle Blaster® machine, to remove the coating and to get a good surface roughness (greater than 60 µm) to ensure the adherence between the tank and the composite solution. Hygrometric conditions were checked and the surface was cleaned and degreased with ethanol.

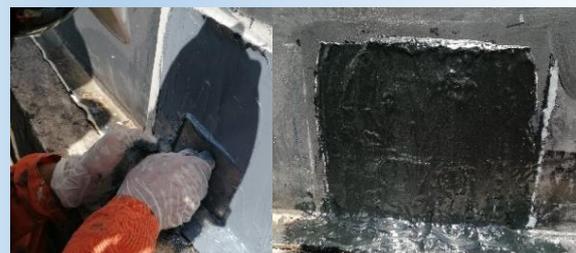
Fig. 4 & 5: Metallic plate and fillers application

- ① **F3XS1 filler** was first applied over the defect to stop the leak and level the surface.
- ② **F3X8 filler** was then applied to create a barrier against the corrosive environment and to facilitate the adhesion of the metallic plate.
- ③ **Metallic plate** was applied over the defected area using a thick layer of **F3X8 filler** to seal the leak.
- ④ Once the curing time of the fillers was reached, the patches installation was started. **Kevlar® patches impregnated with R3X5** were applied to repair the tank. It was necessary to install 5 Kevlar® patches corresponding to 5 layers.
- ⑤ Finally, anti-UV coating was applied to protect the repaired area and identification plate was installed for traceability.

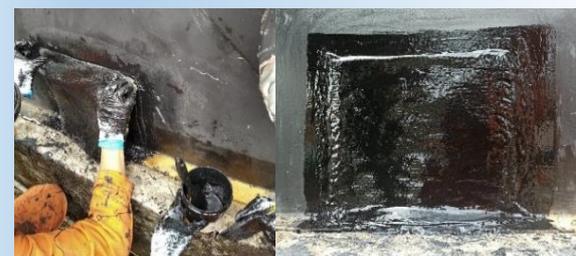
Fig. 6: Composite patching in progress
Fig. 7: Composite patching completed (5 layers)
