# COMPOSITE REPAIR SPECIALIST

- **TYPE OF DEFECT :** Dent, Gouges & Leak
- **PIPE SIZE :** 24" OD (API 5L Grade B, t=8.1mm)
- **NOMINAL PRESSURE :** 12.66 bar
- **PIPE TEMPERATURE :** 60°C
- **LOCATION :** Martinique
- **3X PRODUCT :** REINFORCEKIT 4D (R4D)
- **YEAR OF PROJECT :** April 2014

## OVERVIEW

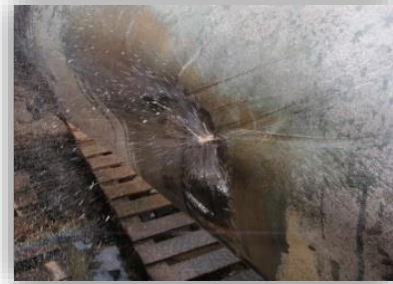
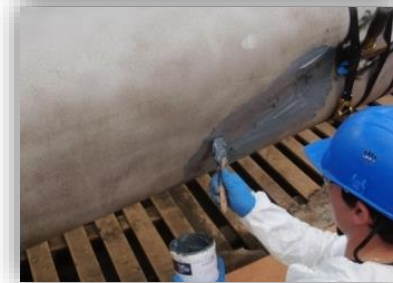
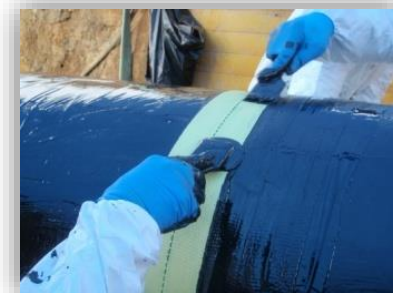
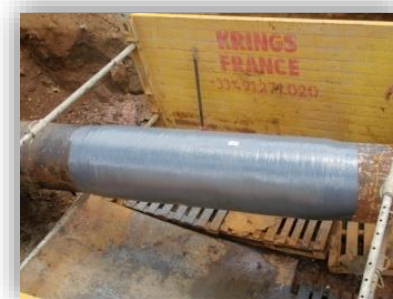
One onshore transfer 24" pipeline was damaged by an excavator which caused both one large dent and a leak. The pipeline reinforcement was performed in April 2014 by 3X ENGINEERING (3X) team.

The whole repair was done according to the proprietary 3X finite elements calculation programme. Twenty (20) layers of composite were found necessary to reinforce the pipeline.

The pipe was fully flooded with water. The leak sealing was done by using arc welding.

F3X8 filler (3X) was applied at the welding area. The dent and its gouges were also filled in with this filler.

Aramide tape was impregnated with R3X5 resin (3X) and helically wrapped with 50% tape overlap.

Curing time of 72 hours was done prior to hydrotest at 10 bar pressure.
