COMPOSITE REPAIR FOR PIPE REINFORCEMENT

According to ISO 24.817 & ASME PCC-2

DEFECT TYPE	External corrosion – 4 defects
PIPE DETAILS	24", 20" & 4.5" - Oil line – max. op. temp. 105°C - application temp. 60°C - design pressure 10 barg
LOCATION	VIET-NAM – FPSO
3X SOLUTION	REINFORCEKIT® 4D ECHT (R4D-ECHT) – High Temperature

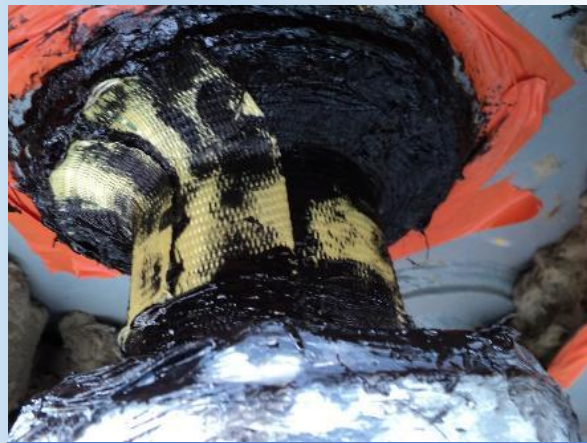
Figure 1: Kevlar® strips application (flare scrubber - part No. 1 of 4.5")

The composite repair for the 2 points of the flare scrubber (4.5" & 24") was then performed following several stages:

- 1 **F3X8 filler** application on fitting & vessel to get a smooth geometry.
- 2 Surface covered with **R3X1080 resin** to ensure a good wetting and impregnation of the Kevlar® tape.
- 3 Kevlar® strips application all around the surface (from the vessel to the straight line) to share the constraints.
- 4 Wrapping process covering the straight line was completed using **Kevlar® tape impregnated with R3X1080 resin (4 layers).**
- 5 Final protective layer of **R3X1080 resin** was applied all over the repair with reference plate positioning for traceability purpose.

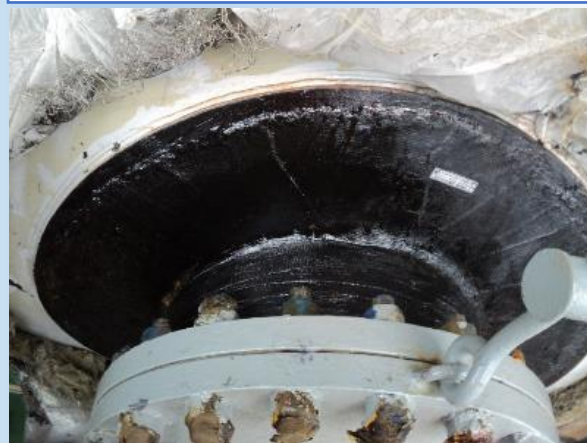
Figure 2: Composite wrapping finished (flare scrubber - part No. 2 of 24")

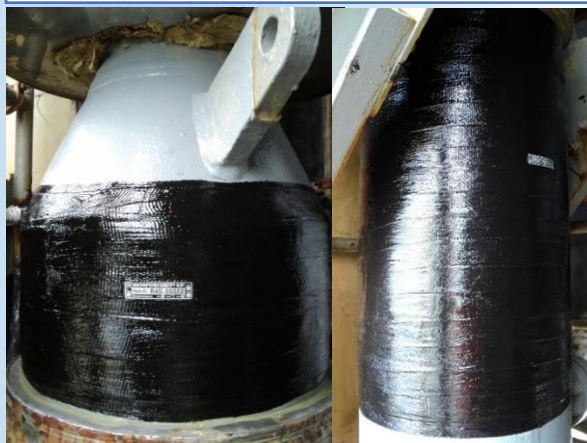
Figures 3 & 4: Composite wrappings finished on heat exchanger (2 defected areas)

The composite repair for the 2 defects (300x350mm & 5x5mm) situated on heat exchanger (24" – straight line) was performed following the same stages, except Step 3. The total repair length for these defects were respectively 850mm & 305mm.
